Peer Reviewed Case Report

ORBITAL FOREIGN BODY DETECTED DURING ROUTINE SCREENING FOR MAGNETIC RESONANCE IMAGING (MRI) EXAMINATIONS: A CASE REPORT TO UNDERSCORE SAFETY PROTOCOLS AND ALSO THE NEED FOR ROLE EXTENSION OF RADIOGRAPHERS IN ZAMBIA

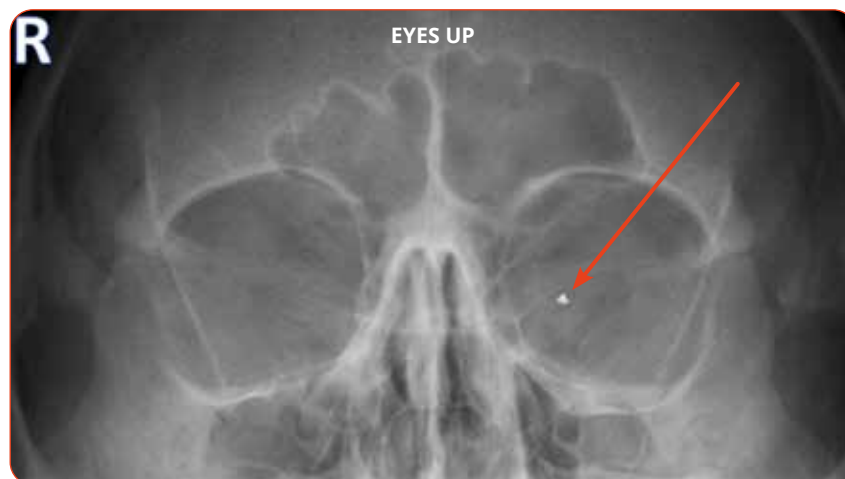
Figure 1. Image obtained with the patient looking up and the FB moved upwards.

In the x-ray room, the radiographer confirmed his identification (name, date of birth, and address) and assessed the justification of the radiation exposure. The erect x-ray digital detector (DR) was cleaned before positioning the patient to ensure it was free of any artefacts that could be confused with IOFB. Two occipital-mental (Waters) projections were undertaken (upward and then downward gaze). Figures 1 and 2 show the radiographic images of both orbits obtained.

Since there was a radiopaque FB demonstrated on the radiographic images as shown in the above images in Figures 1 and 2, the MRI was suspended waiting for a radiologist's report to confirm the radiographer's observation. The radiology department has no radiologist; this led to a delay in obtaining the report. A special request was made to have the radiographic images interpreted at another hospital with a resident radiologist. The diagnostic imaging report read: "Radiopaque foreign body (FB) is demonstrated at

the inferomedial quadrant of the left orbit and changes position at the second view confirming that it lies within the globe. The radiographic features are consistent with metallic intra-orbital foreign body (IOFB). It is risky to perform the requested MRI Brain examination". The report was sent to the referring clinician; the MRI examination was cancelled in line with the advice from the radiologist.

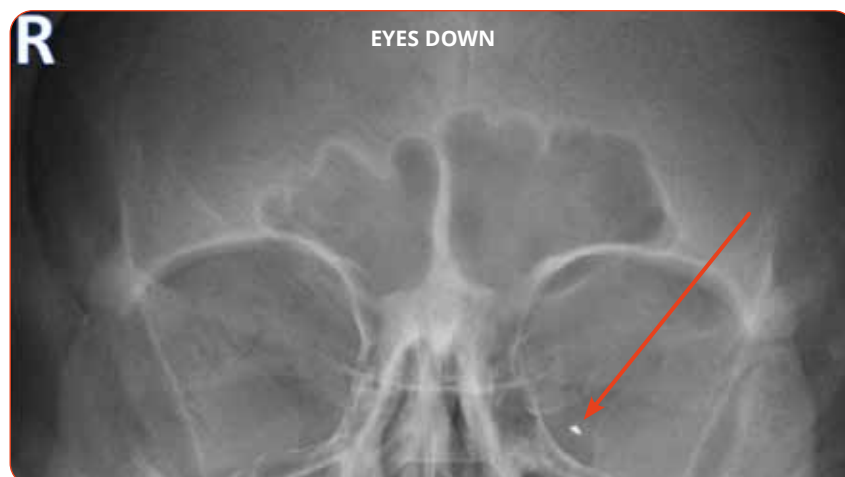
Figure 2. Image obtained with the patient looking down and the FB moved downwards.
