peer reviewed CASE REPORT

Case report: An open book fracture of the pubic symphysis demonstrated by multi-slice computed tomography (MSCT)

This case report describes an open book fracture of the pubic symphysis with an accompanying large pelvic haematoma, diagnosed in a young male following a motorcycle accident. His clinical history, radiological findings as well as treatment are discussed.

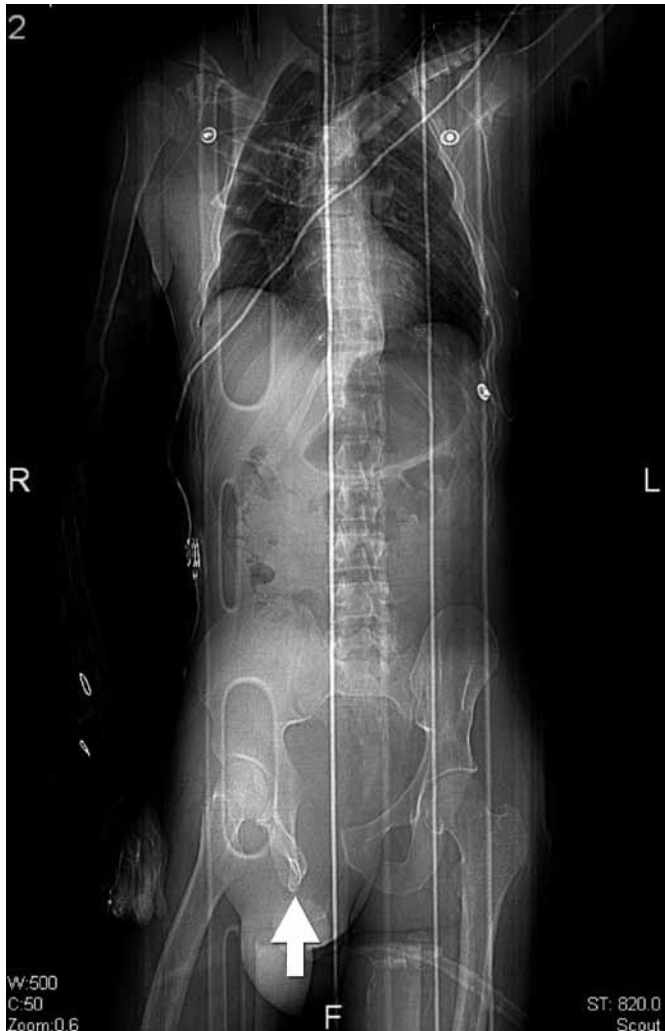
Figure 1: Anteroposterior (AP) scout projection, showing the open book fracture of the right pubic symphysis (arrow).

An open book fracture was seen at the pubic symphysis (Figure 1 and 4). Active haemorrhage was present in the right adnexal area with a large haematoma displacing the bladder in a superolateral direction (Figure 2 and 3). Some haemorrhage was noted in the mesenteric root. Oedema in the anterior abdominal wall was also identified (Figure 3).

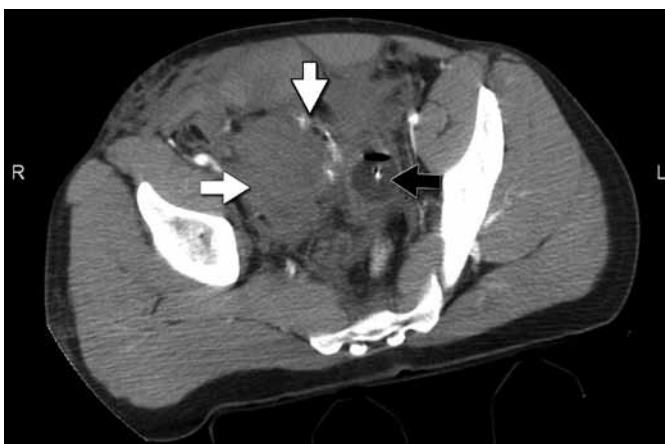
Figure 2: An axial projection of the abdomen showing contrast extravasations of contrast media (top white arrow with black outline). Also note the haematoma on the right side of the pelvis (white arrow) displacing the bladder to the left (black arrow).

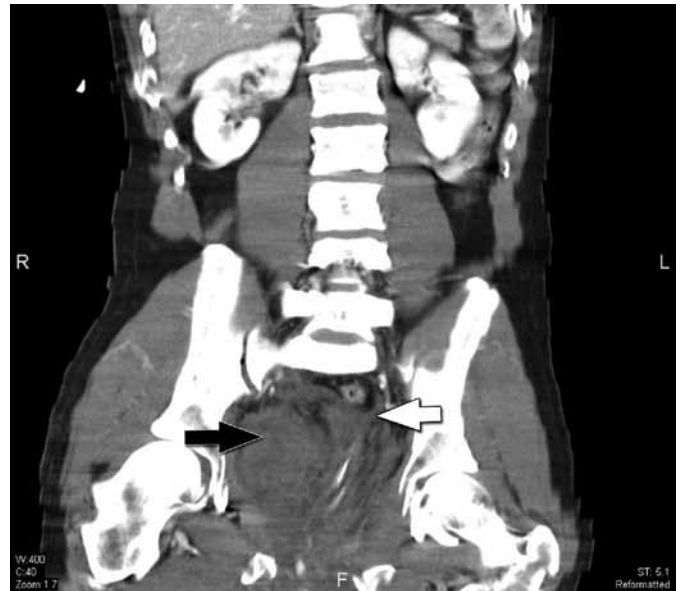
Figure 3: A coronal view of the abdomen depicting the large haematoma (black arrow) displacing the bladder (white arrow). Movement artifacts are noticed (see lateral ribs).

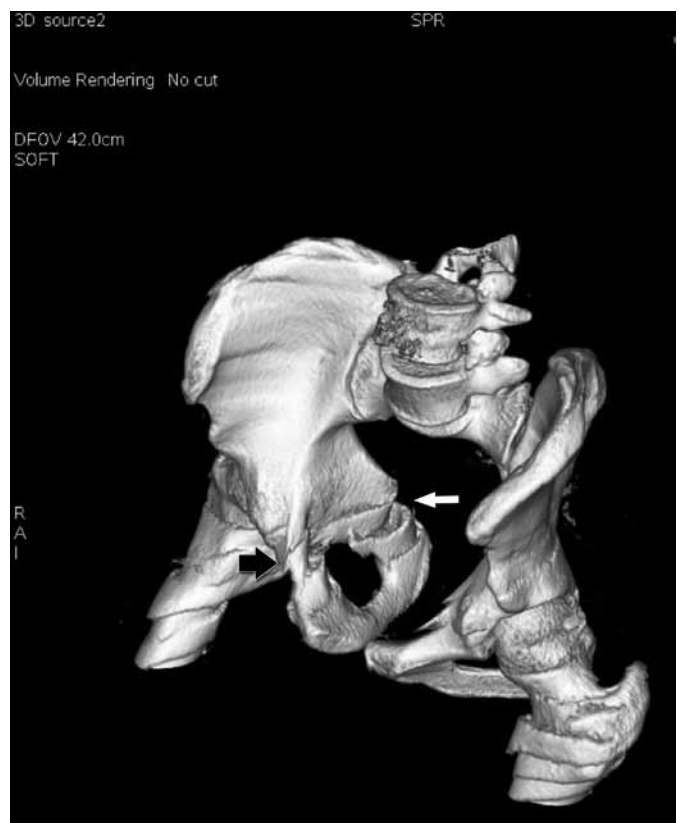
Figure 4: Three dimensional (3D) volume rendered image indicating the location of the open book fracture on the right side of the pubic symphysis (black and white arrows).

and provide soft tissue and bone detail in a single scan. Post-processing techniques, such as 3D volume rendered imaging, provide detail regarding the extent of the fracture and aid the surgeons. Sagittal and coronal post processing of the axial imaging provides data in different planes^[6-8].
